2 15
LIBBY DAM AND LAKE KOOCANUSA PROJECT, MONTANA

LEFT BANK SLOPE

REPORT DOCUMENTATION PAGE		READ INSTRUCTIONS BEFORE COMPLETING FORM
1. REPORT NUMBER	2. GOVT ACCESSION NO. AD A142 021	3. RECIPIENT'S CATALOG NUMBER
4. TITLE (and Subtitle) Libby Dam and Lake Koocanusa Project, Montana Left Bank Slope		5. TYPE OF REPORT & PERIOD COVERED Final

20. ABSTRACT (Continue on reverse side if necessary and identify by block number) Report details the geology and history of the Libby Left Bank Slope instrumentation program, presents plots of instrumental data for the period 1967-1983 and provides a technical evaluation of the present status of the slope.

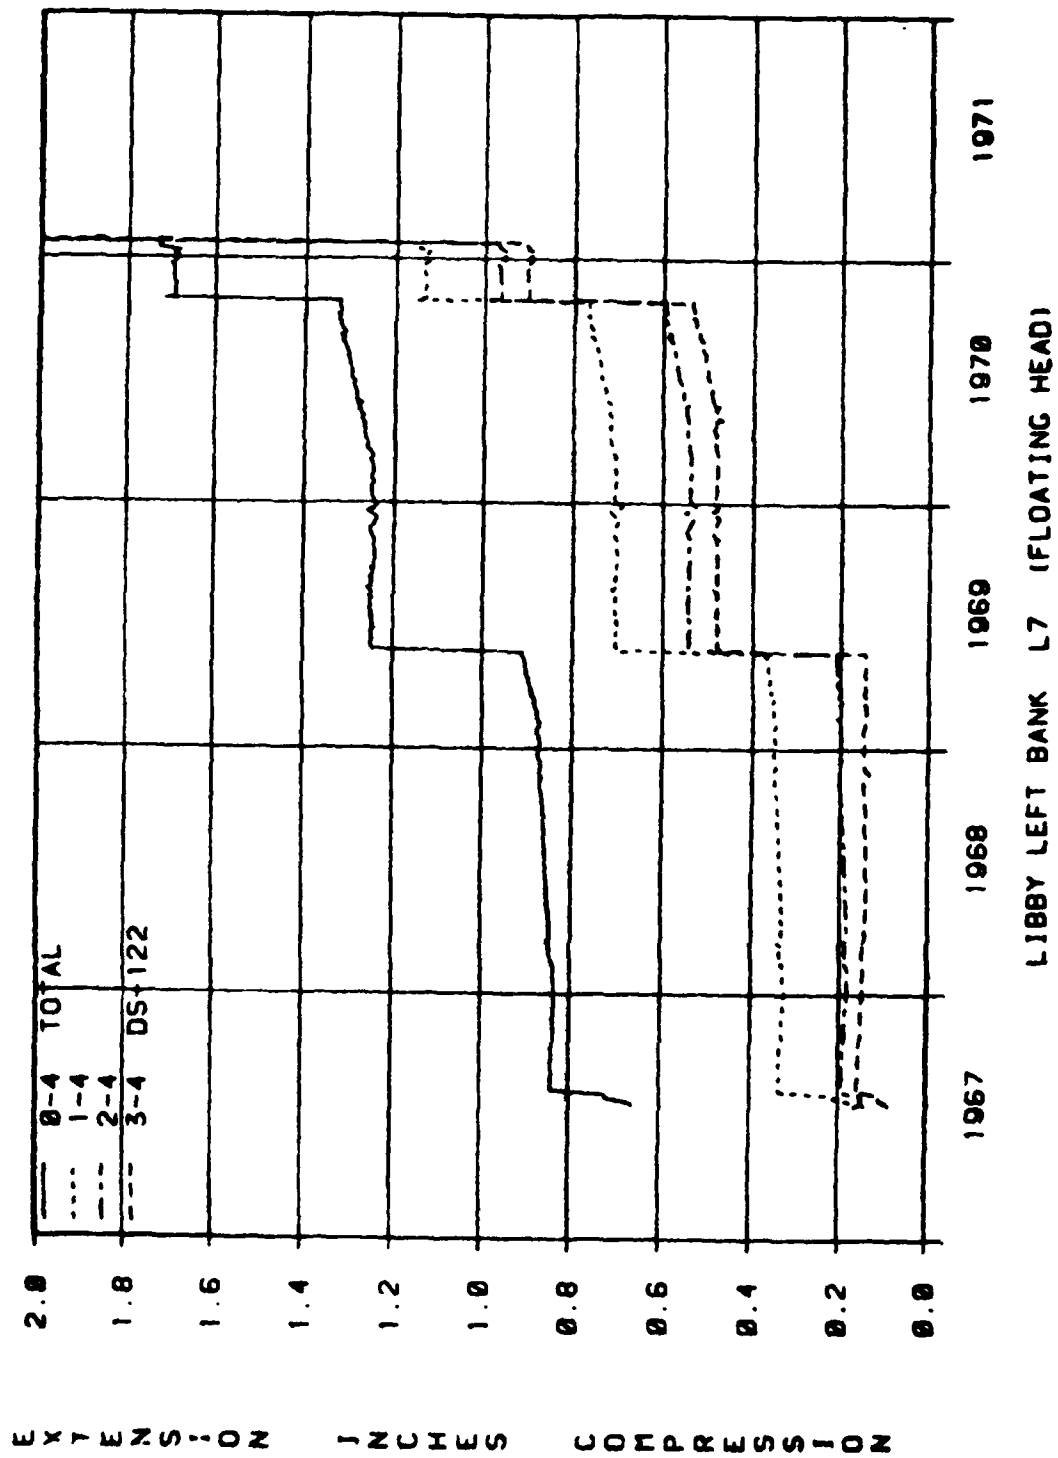
FIGURE 3.3

f. Late in March 1970, L-7 again began to indicate valleyward creep of the rock mass outboard of the DS+122 (figure 3.3). Some acceleration of this creep began in May and continued throughout the summer. The District forecast that a second step or failure would occur and that the magnitude of the movement was already greater than the precursor to the first step. When the Board of Consultants met at Libby on 29-30 July 1970, they were presented not only with a revised design of this section of the highway encompassing large amounts
